## Negative environmental impacts generated by cemetery: Case study

This work aimed to perform an analysis of the negative environmental impacts generated by a public cemetery in the municipality of Escada, located in the Zona da Mata Sul of Pernambuco, through on-site inspections and using the Leopold matrix.

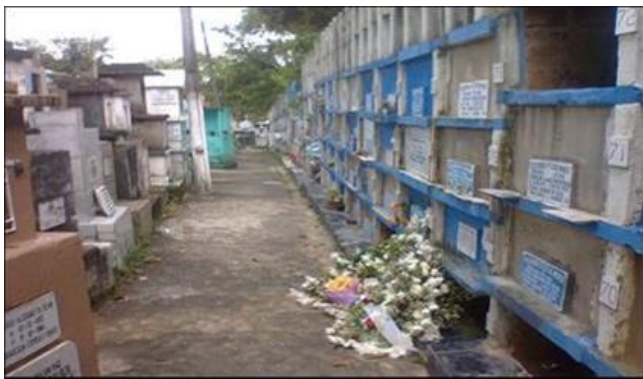
The cemetery is located in the center of the municipality of Escada, state of Pernambuco, where there are several residential and commercial establishments. Today, the cemetery is overcrowded, with no vacancies to build new deposits. The type of burial offered by the Cemetery is by burial, which are constructions of concrete boxes or masonry in horizontal and vertical form. The type of burial can also contribute to increase, control or decrease pollution. Comparing the swelling with the swelling, the swelling is the most recommended technique, but the construction of the deposits needs to be well executed to avoid the leakage of leachate and gases<sup>4</sup>. Figure 1 shows the types of deposits found in the cemetery by horizontal and vertical accumulation.

**Fig 1:** Types of burials - Escada Cemetery - PE. Source: The authors.

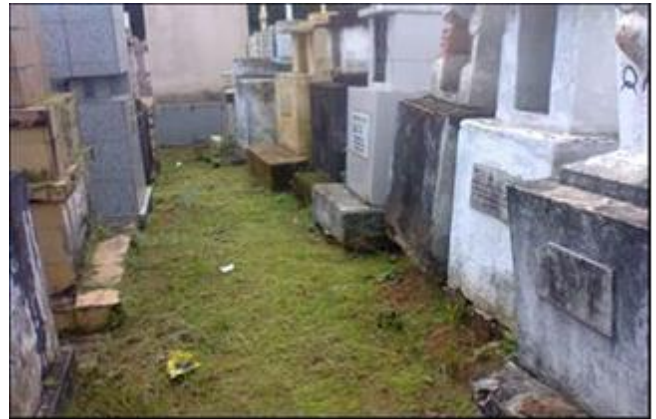
The cemetery has approximately 1200 graves, many are considered centenarians, and some are in total abandonment. Families can reuse them after a minimum of three years for adults and two years for children. According to the information gathered on the site, the construction of the tombs does not involve any special material, they are made of sand, cement and bricks without any waterproofing. However, Article 6 states that the construction of tombs must obey technologies that prevent the passage of gases and the leakage of liquids from colliquation<sup>6</sup>. It was also noted that not only older deposits have structural problems, but also newer ones, including retired ones (Figure 2). It is

noteworthy that these tomb construction problems can cause leakage of leachate and emission of gases into the environment<sup>3</sup>. classifies this type of impact as secondary physical, which are directly linked to the poor preparation and maintenance of deposits.

**Fig 2:** Structural conditions of the graves in Escada cemetery. Source: The authors.

Ways to mitigate the responses presented by the Leopold matrix would be through the Environmental Risk Prevention Program (PPRA) or Immediate Tomb Recovery to prevent leakage of liquids from colliquing and also treatment of any gaseous effluents, using, for example, activated carbon.

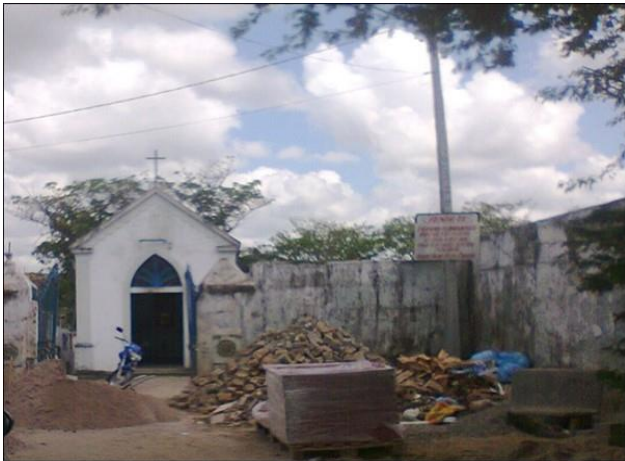
In the on-site technical visit, it was found that the city does not follow the norms for the conditioning, treatment and final disposal of this type of waste. The management of the waste generated in the cemetery is inadequate because they are exposed to the environment and the local community without any sanitary and environmental care.

Waste is placed in front of the cemetery, waiting to be collected by the city, which gives the final disposal in the private landfill, or thrown into a vacant lot near the cemetery (Figure 3). The management of solid waste from cemeteries must comply with technical standards to

**Fig 3:** Inadequate disposal of solid waste generated in the cemetery. Source: The authors.

There are numerous solutions to the environmental problems generated by cemeteries, where studies by<sup>12, 13, 14</sup> for example, prove the efficiency. However, the existence of a solid waste management plan for proper sanitary disposal of the generated waste and vector control is essential for the reduction of environmental risks. The construction of an ossuary and the implementation of an adequate rainwater drainage system to safely capture and route rainwater runoff are essential for proper management.

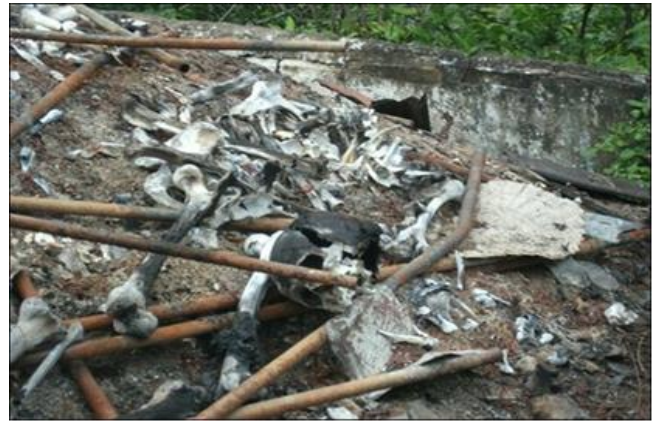
After the deadline for the exhumation of the bodies has elapsed, and if the family does not attend, the exhumation and human remains are burned in the cemetery itself, being a criminal act that infringes the Arts. 208 to 212<sup>11</sup> that deals with crimes against religious sentiment and respect for the dead, as well as the release of pollutant gases into the atmosphere (Figure 4). The justification given by the local administration is due to the lack of ossuary in the cemetery.

**Fig 4:** Burnt bones in the cemetery and surrounding areas. Source: The authors.
